## Inspection Field Notes for Former Plastech-Andover Facility

Facility&Address: Former Plastech Engineered Products, Inc.-Andover  
205 Maple Street Extension  
Andover, OH 44003  
ID number: OHD068896778  
Inspector: Frank Zingales (FZ) and Frank Popotnik (FP)  
Date: 6-13-12  
Time: 1130-1245  
Purpose of Inspection: Identify status of facility.  
Sample(s) Taken: No  
Photograph(s) Taken: Yes

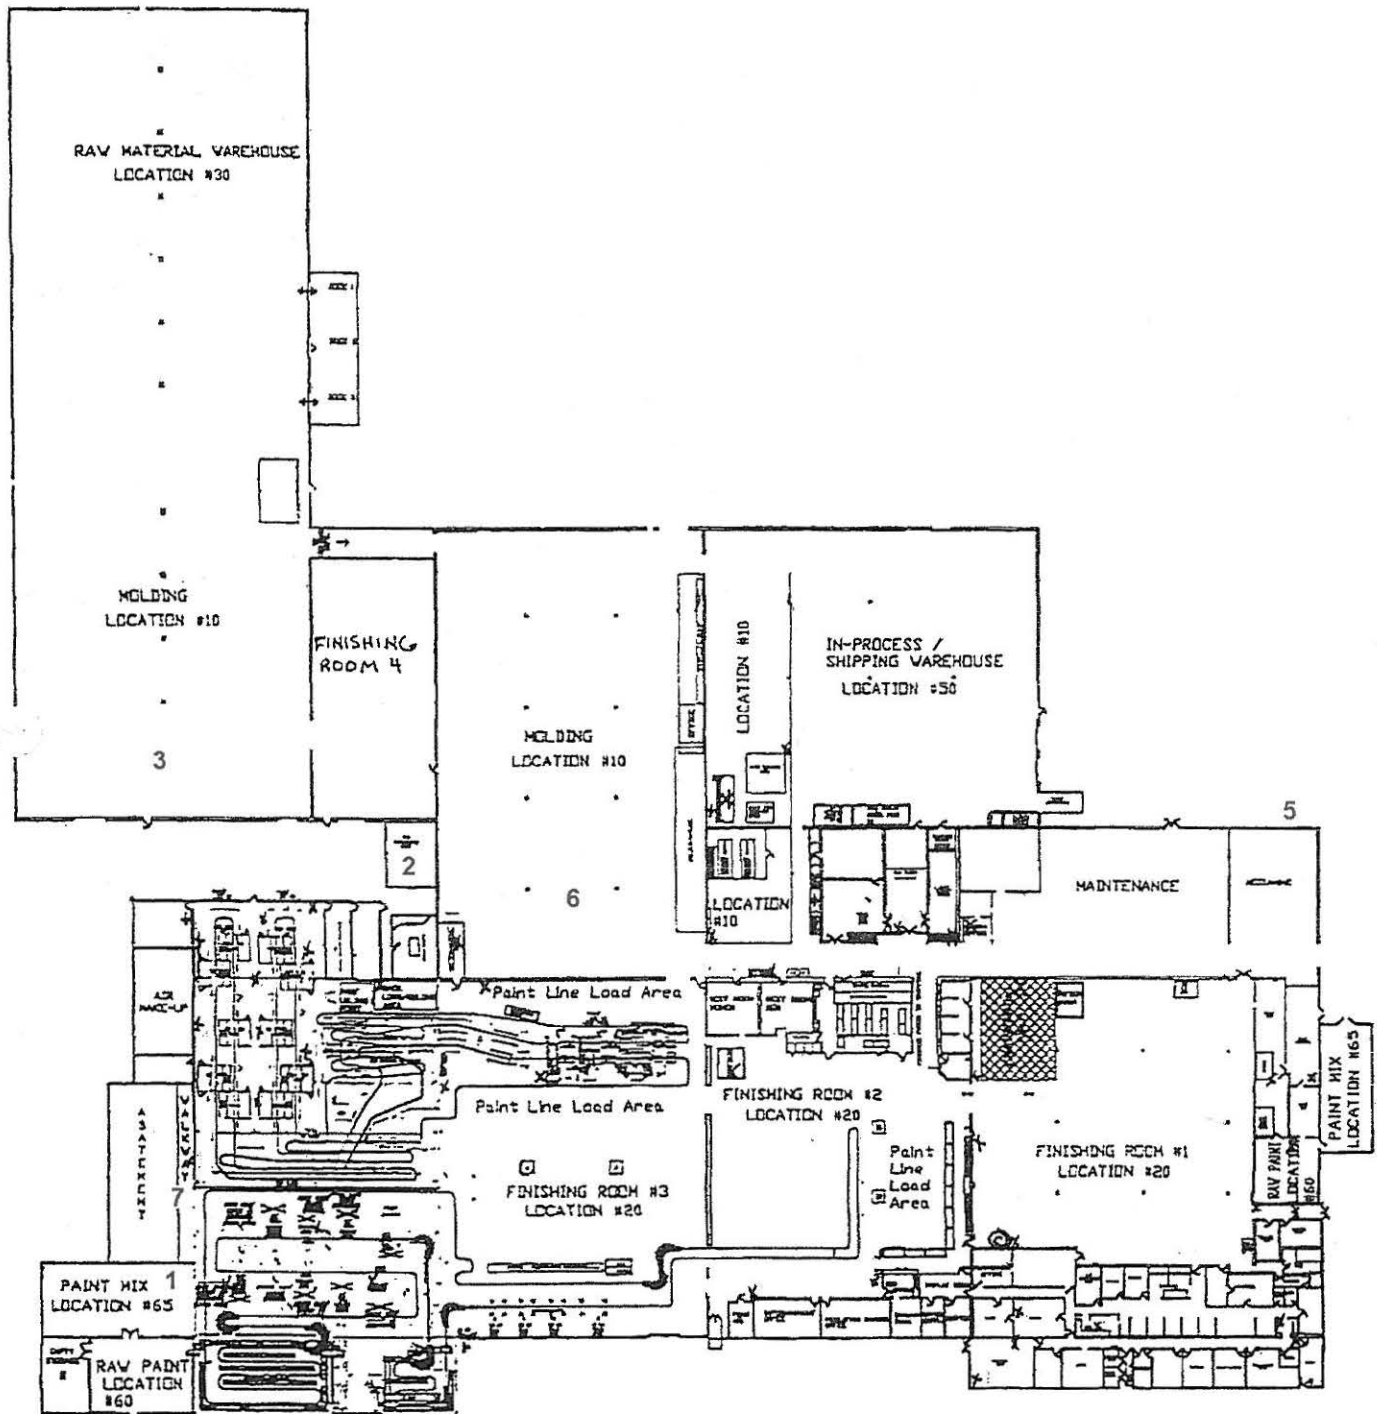
6-13-12 001

Photo #	Area / EPA Location	Description
1-3	1	Paint Mix Location #65, North Paint Kitchen: Sump with approximately 12" of paint waste in bottom.
4&5	1	Paint Mix Location #65, North Paint Kitchen: Exterior door open/unsecure and window broken.
6&7	Air Abatement	Former Air Abatement System – Exterior perspective view.
8&9	2	Room West of Finishing Room: Exterior door open/unsecure. One, 55-gallon drum, full, with contents.
10-12	3	Molding Location #10 (EPA location 3) and Raw Material Warehouse Location #30: Two exterior doors open/unsecure. Shop vac with oil.
13-15	4	South side of property, exterior building: Door open/unsecure. Approximately 12, 5-gallon pails with contents. One pail labeled as Oxidizer 5.1.
16-25	5	Southeast side of property: Fence gate open/unsecure around 3 transformers (numbers 91780, 91781 and 91782). Label indicated PCB content <50 ppm. Two transformers were leaking oil at base. Evidence of vandalism at electrical panel.

- Exterior door open/unsecure and window broken.
- Interior – Paint/solvent related waste present in trench drains and sumps. Waste had a paint/solvent odor. Observed two sumps, each approximately 30" X 30" with 12" and 4"-6" of paint waste, respectively, in bottom.
